Historical Repair Zone Identification

Surveys for undocumented and non-visible repair zones were conducted on Highway 401 in Toronto, Ontario to plan maintenance and road upgrades. The highway in this area is 40 years old and has seen many upgrades and repairs. Two sites are marked on the Google Earth map in Figure 1.

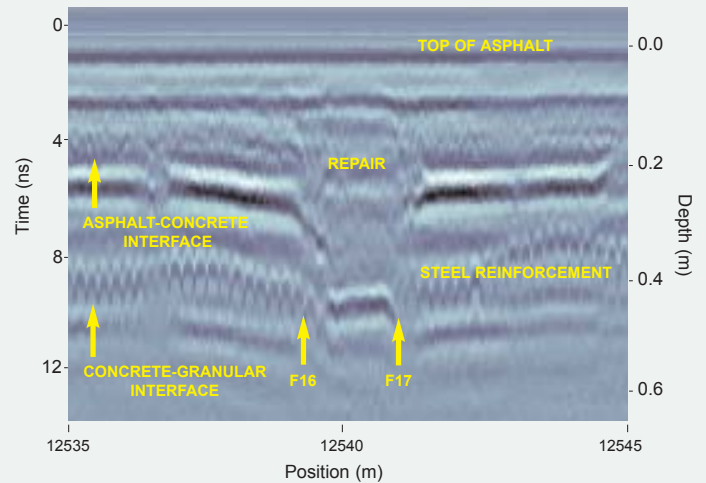
Figure 2, shows results from “Site 1”, that highlight a repair zone where part of the entire concrete slab has been removed and the slab to the immediate left is tilted.

Figure 2: Detailed investigation of Hwy. 401 - “Site 1”. Fiducials 16 and 17 indicate surface cracks observed during GPR data collection. A previous repair and tilting of the concrete slab to the left of the repair are clearly visible in this GPR section. The surface cracks bracket the repair.

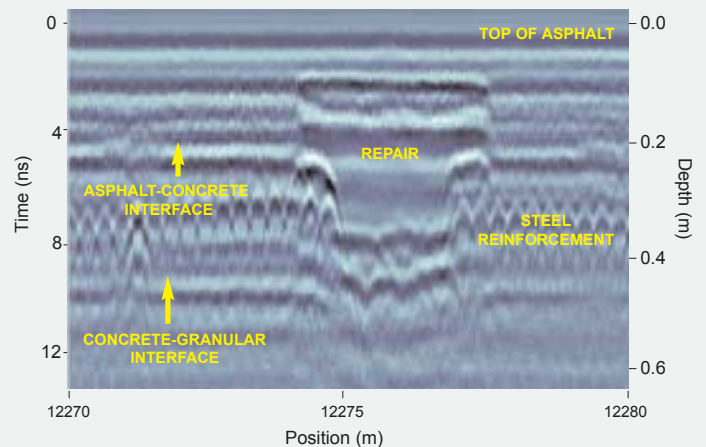
Data from “Site 2”, shown in Figure 3, indicates a different construction repair character.

Figure 3: Another repair zone on Hwy. 401 - “Site 2”. In the repaired section, the steel reinforcing and possibly the concrete slab have been removed.
