Construction-Practice Classifications

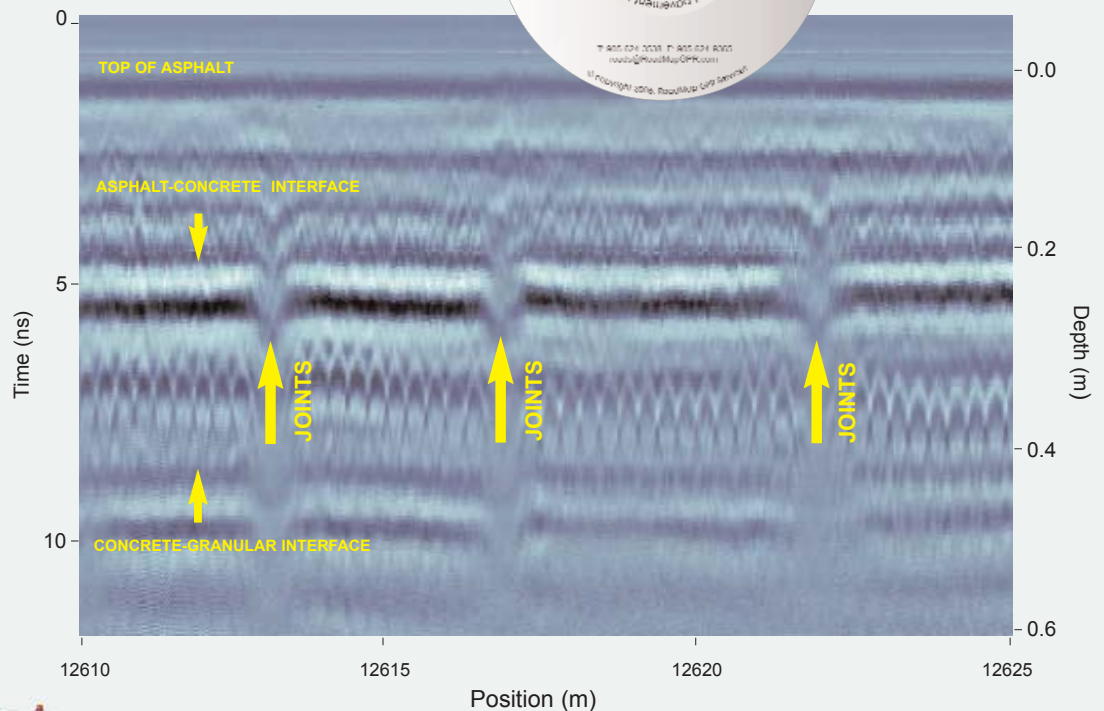
Figure 2: Survey data showing joints in a concrete slab covered by asphalt (indicated by yellow arrows). Disturbance observed in asphalt above the joints indicates movement of asphalt layer has occurred above joints which lead to cracking and the potential for water inflow.

An example of GPR image in Figure 2 shows a short section of the road. This character was observed over several kilometers indicating the uniform road construction practice.

After correlating the GPR with other data, the abrupt localized changes were confirmed to be joints in the underlying concrete slab. The change in signal character is associated with fine grained material and water retained in the concrete joints.

Slight deformation of the asphalt structure above the joints suggest upward migration of the deformation. These characteristics are clear indicators of slab movement at the joints.
