Historical Repair Zone Identification

Surveys for undocumented and non-visible repair zones were conducted on Highway 401 in Toronto, Ontario to plan maintenance and road upgrades. The highway in this area is 40 years old and has seen many upgrades and repairs. Two sites are marked on the Google Earth map in Figure 1.

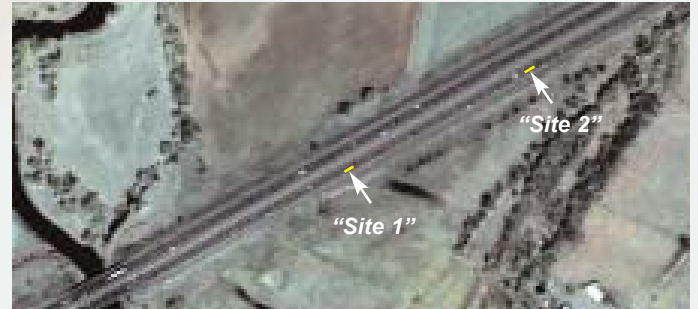
Figure 2, shows results from “Site 1”, that highlight a repair zone where part of the entire concrete slab has been removed and the slab to the immediate left is tilted.

Figure 2: Detailed investigation of Hwy. 401 - “Site 1”. Fiducials 16 and 17 indicate surface cracks observed during GPR data collection. A previous repair and tilting of the concrete slab to the left of the repair are clearly visible in this GPR section. The surface cracks bracket the repair.
